# VII. PHYSICAL PLANT INVENTORY

## Lake Waccamaw State Park Building Inventory

\_ake Waccamaw State Park

Plan Update

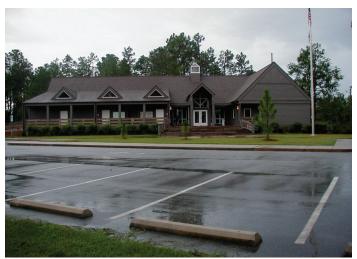
<u>Visitor's Center/Park Office</u>: Building # 033011. Built in 1998. The one story wood-frame structure has 5,940 heated square feet and a cathedral ceiling. It contains administrative offices, an auditorium, exhibit hall, classroom and public restrooms. It is in excellent condition.

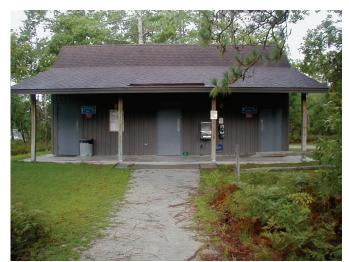
**Toilet Building:** Building # 033008. Built in 1990. The woodframe, 540 square foot structure has a shingle roof and board and batten siding, with a one-person office and storage in the center. Located in the picnic area. It is in excellent condition.

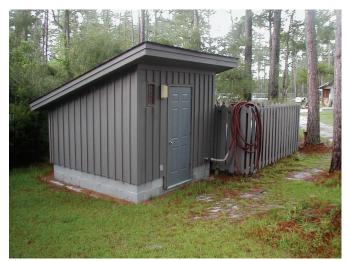
**Pump House:** Building # 033007. Built in 1990. The 81 square foot unheated wood-frame building is used as a pump house. It is in good condition.

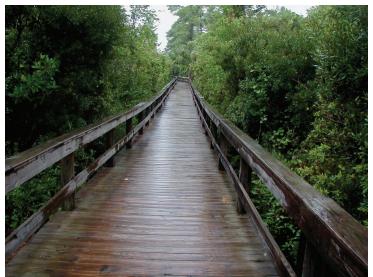
Picnic Area Boardwalk: Renovated in 2001, the 8' x 700' boardwalk leads to a 24' x 24' Overlook Shelter (next photo), an 8' x 375' Pier, and two 32' x 50' patios (photo on following page). Renovation cost was \$43,150.

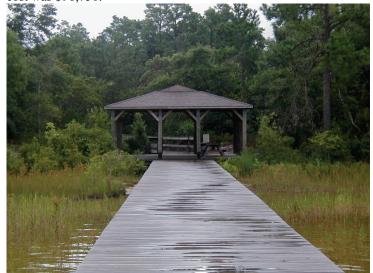
Overlook Shelter: Located at the end of the picnic area boardwalk and start of pier.

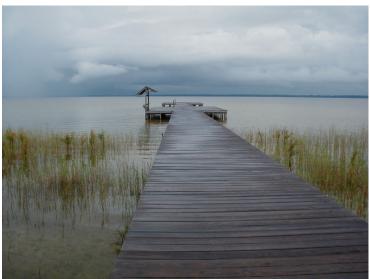
<u>Pier:</u> View from the overlook shelter showing the patios on the picnic area pier.

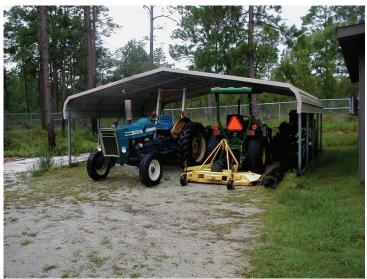
<u>Aluminum Equipment Storage Shed</u>: Located in the maintenance area and used as a temporary storage shed.

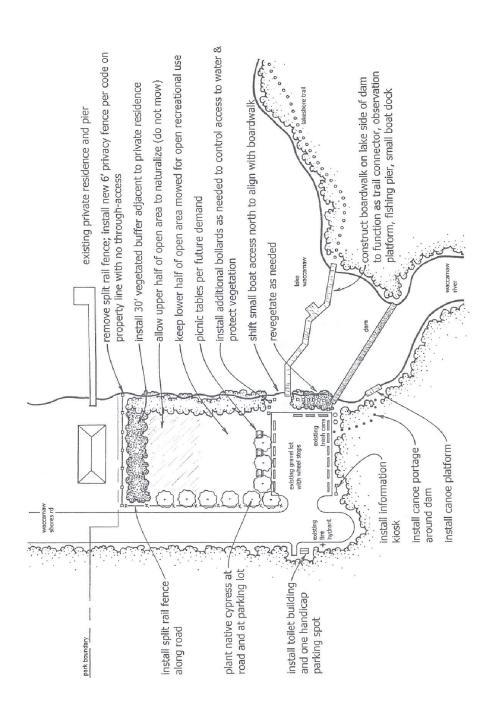
River Access

- 3. <u>River Access and Trail Improvements</u>: This project includes trail signage, improvements to three miles of trail, three primitive campsites with a pit toilet, canoe portage with a handicapped-accessible dock, split rail fencing and vegetative buffer, a pump station, an entrance sign, a boardwalk with a platform and a boat dock to connect the trail across the Waccamaw River. It also includes

- a flush toilet building with solar power assistance, a handicapped parking space, an information kiosk, a force main extension to the town sewer, and four picnic tables
